GE MK V TCPSPG Power Supply Refurbishment Program

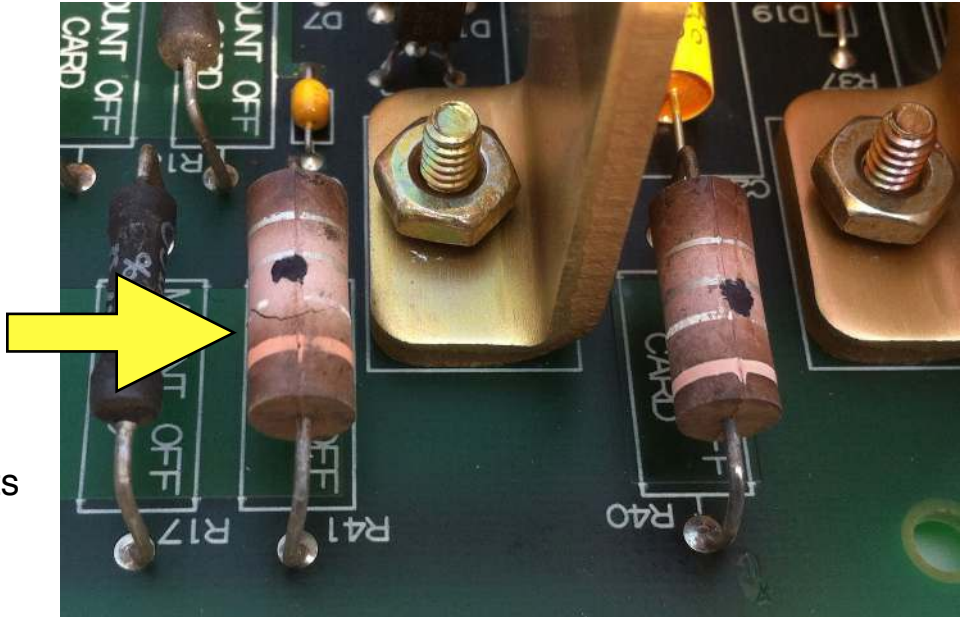
This picture is from an operating MK V Power Supply.

If the resistors on your Power Supplies look like this

Then the unit will likely fail in operation

Operational failure results in expensive damage to other cards

Powergenics offers a preventative solution to extend the life of TCPSPG power supplies!

After evaluating over 100 previous repairs, Powergenics recommends a 16 component upgrade

These new components are higher quality and ensure longer life.

Refurbishment turnaround is 2 weeks with **two year warranty**
